# THE *NORWAY* BOILER EXPLOSION

*At 0637 on May 25th, 2003, the passenger vessel Norway (formerly France), suffered a boiler rupture in the aft boiler room about an hour after the vessel had moored in Miami, Florida, at the end of a seven-day Caribbean cruise. Eight crewmembers sustained fatal injuries, 10 suffered serious injuries, and seven received minor injuries. No passengers were injured*

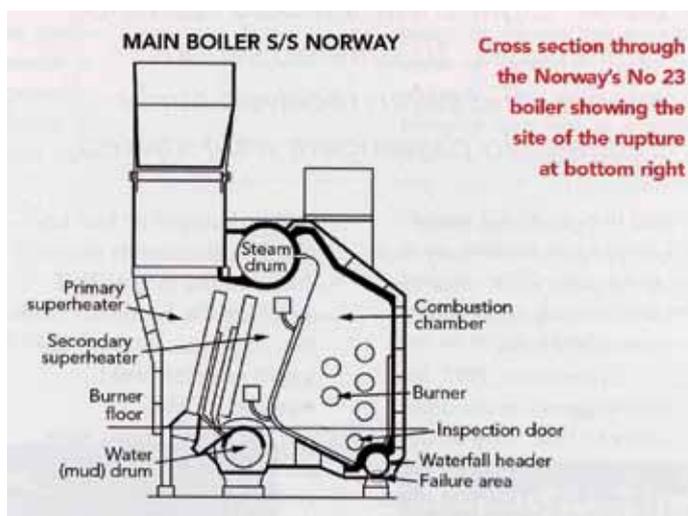
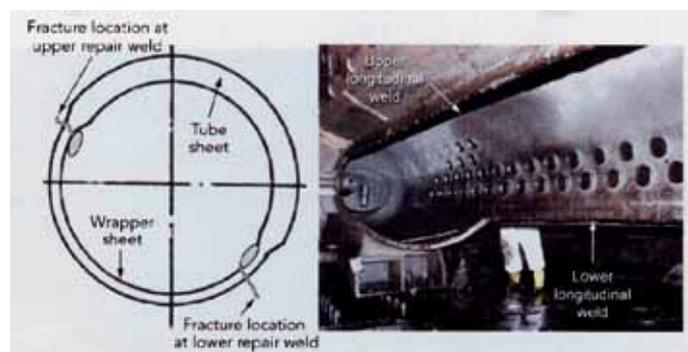
Company reports and classification society surveys documented cracking, corrosion, pitting, and tube failures throughout the history of the ship's boilers. As early as December 1970, cracks were observed in the longitudinal welds of the waterwall headers, water drums, and steam drums of all four boilers. The documents also indicate that the longitudinal welds on the header of boiler No. 23 (the boiler that ruptured) were last weld repaired in 1990.

Schematic (left) showing location of fracturing along the longitudinal welds, and partial view (right) of damaged waterfall header, looking aft. The waterfall header was constructed by longitudinally welding together two half-cylinders and then welding caps (dished heads) on either end. The two half-cylinders were of different thicknesses. During the manufacture of the header, the tube sheet was tapered down to the wrapper sheet and the two were welded together at the bottom of the tapered region. The header fractured where weld repairs had been made along the original longitudinal welds joining the tube sheet and the wrapper sheet

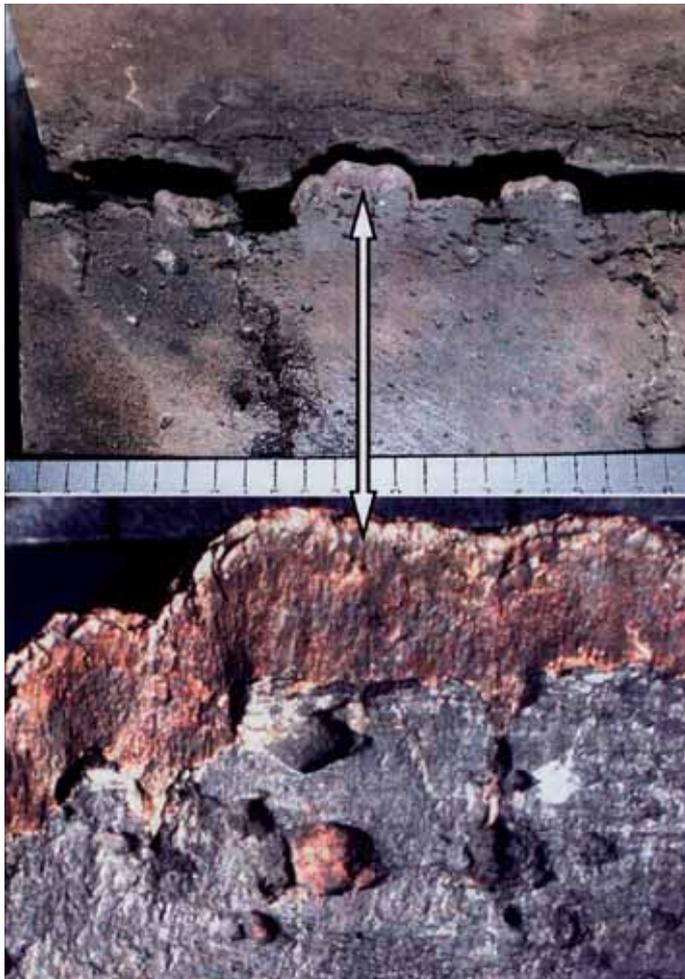
View of matching fracture halves (above) and enlarged image of copper nuggets (below) at the edge of the fracture. Arrow points to area of enlarged image. It appears that copper tubing may have been deliberately introduced into the boiler waterwall header during a misguided maintenance action

- Lack of adherence to water chemistry composition limits and procedures by both the water chemistry subcontractors and NCL during wet lay-up periods, leading to pitting from oxygen corrosion
- Failure to take number of boiler cycles into account during maintenance
- Severe thermal transients from heating and cooling the boilers too quickly and from constraints created by frozen boiler support feet
- Use of questionable weld repair procedures
- Lack of appropriate non-destructive testing by the BV surveyors and NCL inspectors to determine whether cracks were present
- Inadequate survey guidance from BV to its surveyors
- Failure to repair cracks into which copper had been inappropriately introduced.
